SMYTH, J.S. and MATHER, A.S.

BEACHES OF EAST SUTHERLAND AND EASTER ROSS

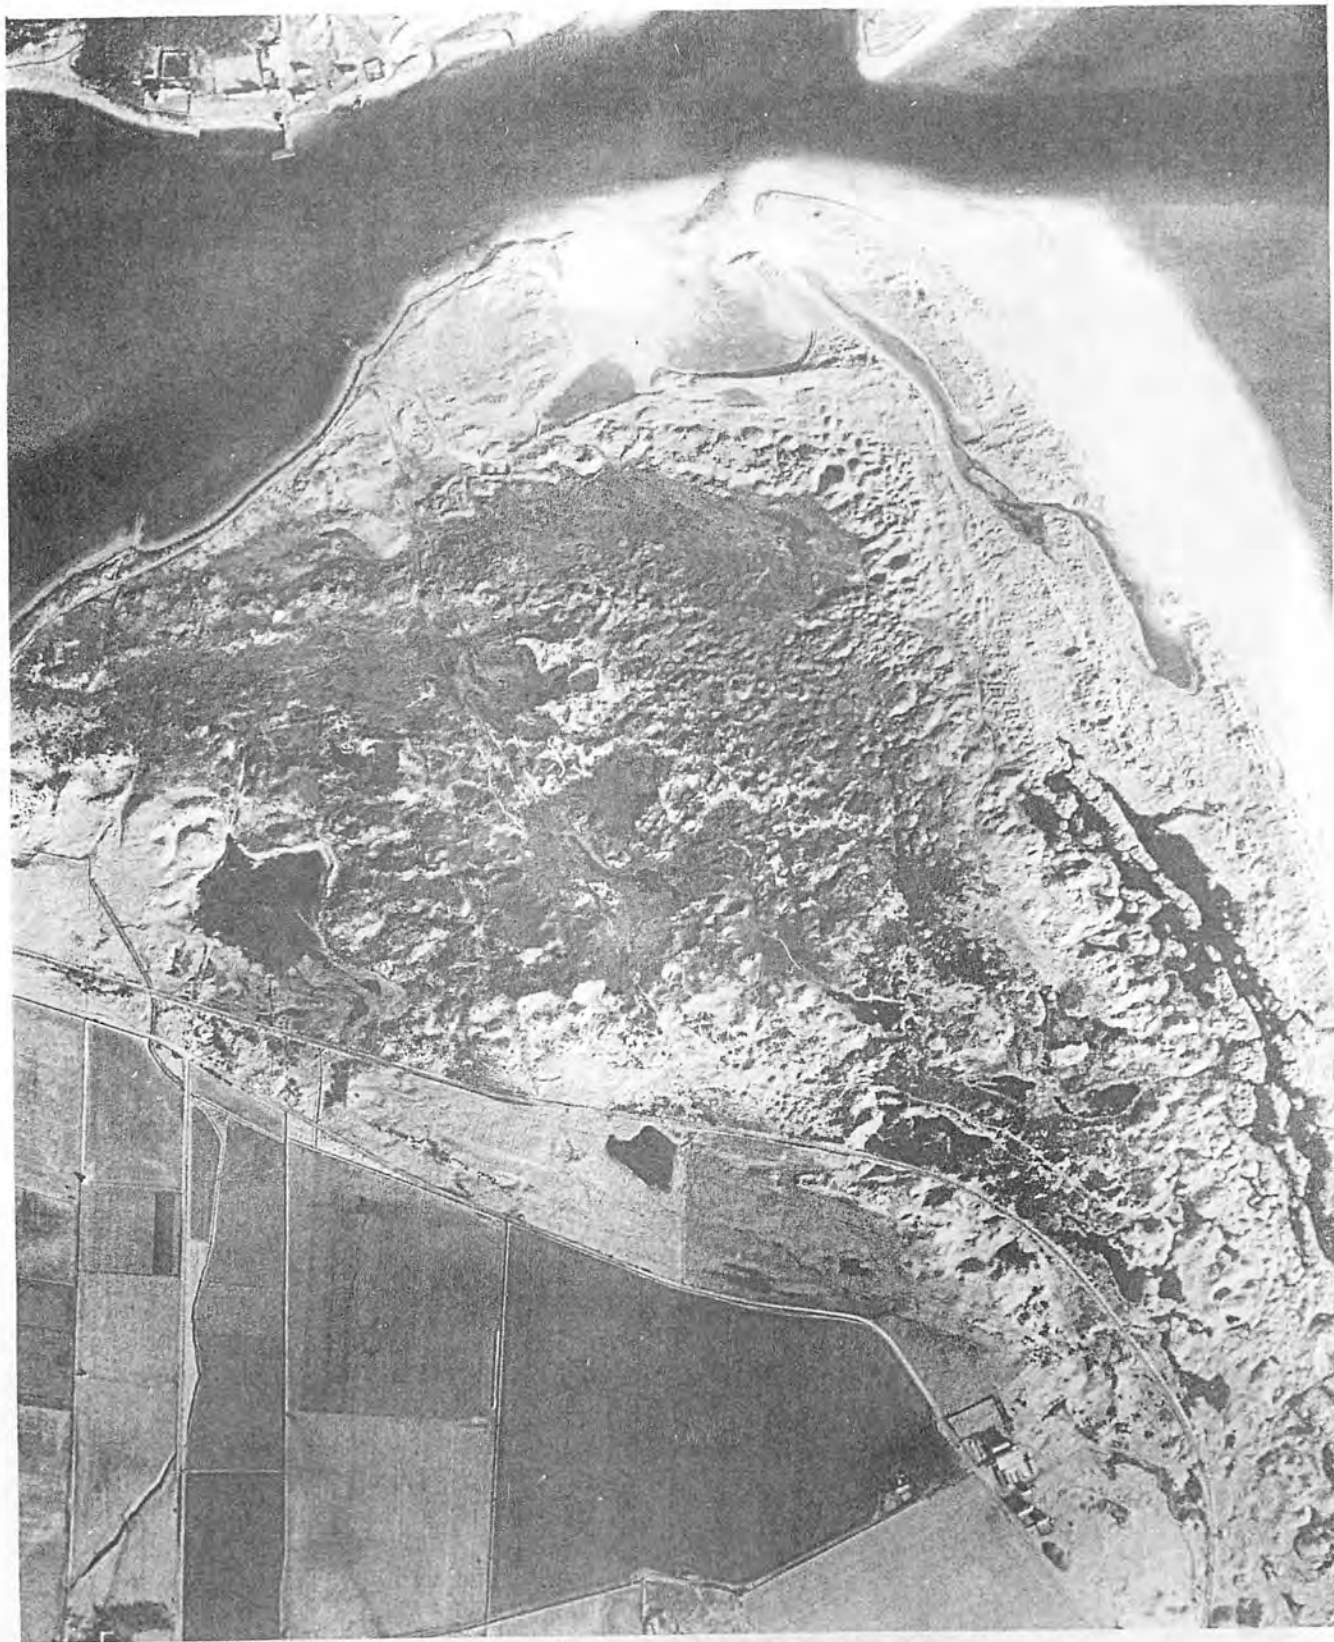
6.7.5. Coul Links - note the wet slack, and the contrast between dune heath and dune pasture areas.

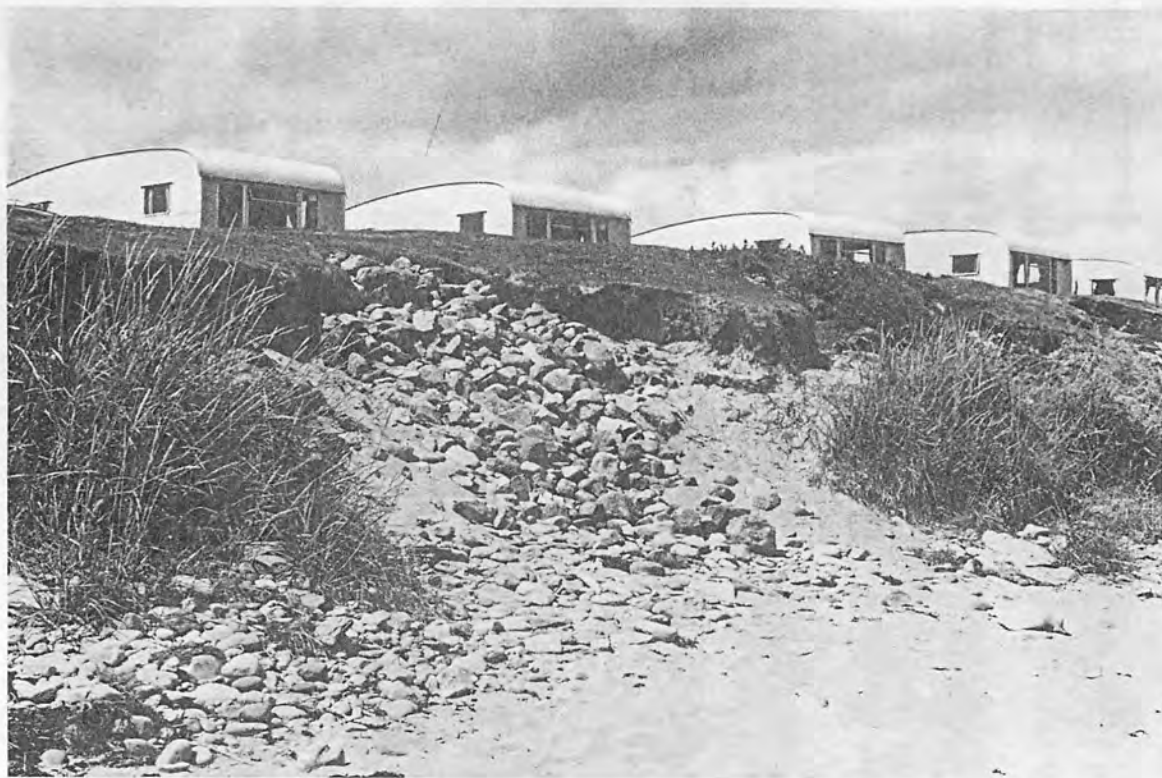
6.8.1. The coastal edge at Embo caravan site. Stones have been tipped to counteract trampling damage.

.9 Embo Links are probably one of the Highland beach units most suited for intensive recreational use, and there is no reason why caravanning should be seriously curtailed. Some relatively minor management measures are, however, required, and should be implemented as soon as possible. The first of these measures is the construction of an impassable fence along the coastal edge behind the north beach sector. The objective of this measure is to control trampling damage along the coastal edge by channelling all access through two or three points which can be protected by a sleeper staircase or other means. If such control is effected, there would be very much less danger of blow-out development resulting from trampling, and the need for tipping stones in the incipient blow outs would be removed.

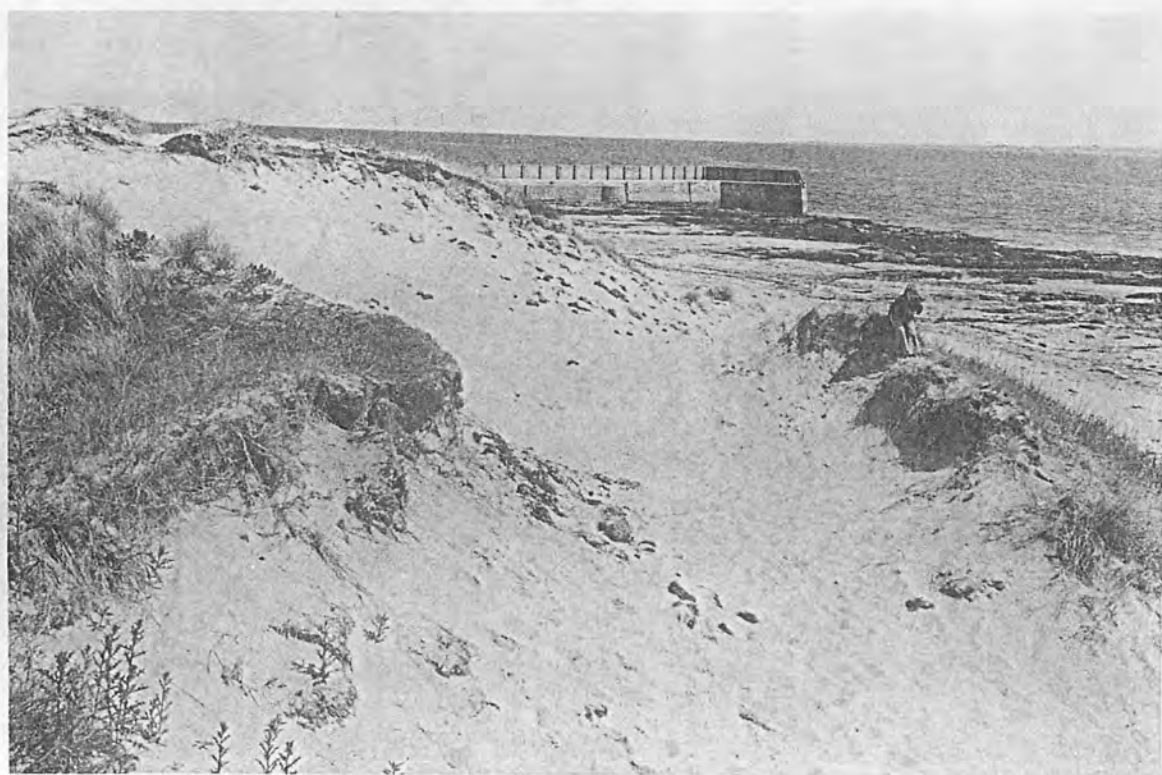
6.8.2. Embo beach and dunes - central section. A large active blow-out, in which trampling has accelerated rates of deflation.

Damage has progressed further in the dune zone behind the central beach sector, and will be less easily controlled. The first priority should be the exclusion of people by the construction of a ring fence around the damaged area and its environs: thereafter a suitable grass seed mixture should be sown and ideally protected by either latex or bitumen films. Sea lyme grass should be transplanted around the dune toe and lower part of the seaward slope.

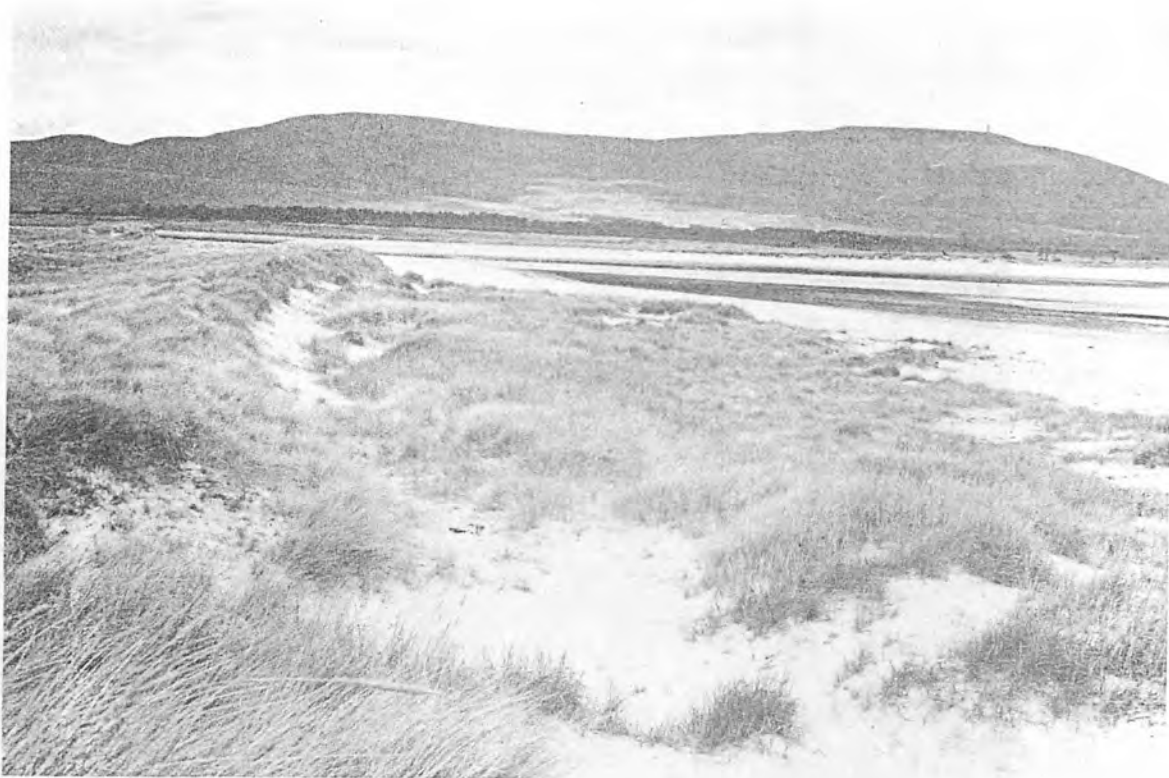
6.7.1. Coul Links - rapid accretion on the coastal edge near the north-east corner.

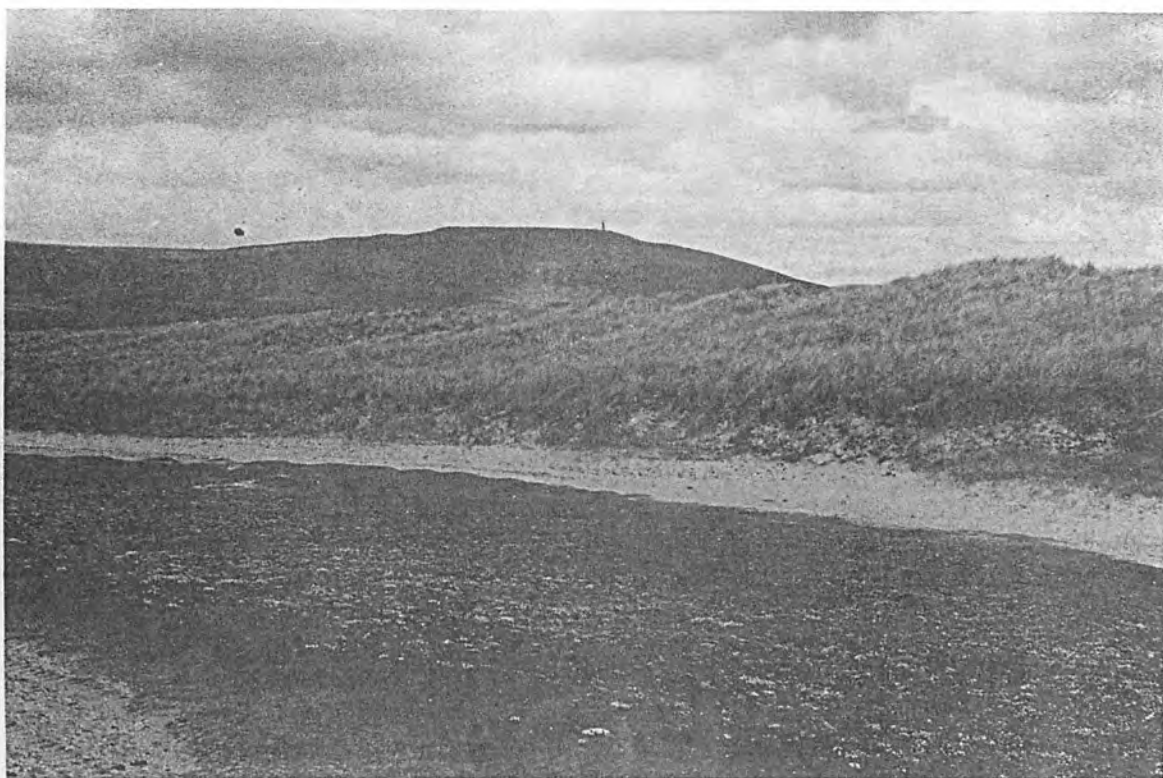
6.7.2. Coul Links - vegetating sandflat, still very occasionally inundated, between dune ridges.

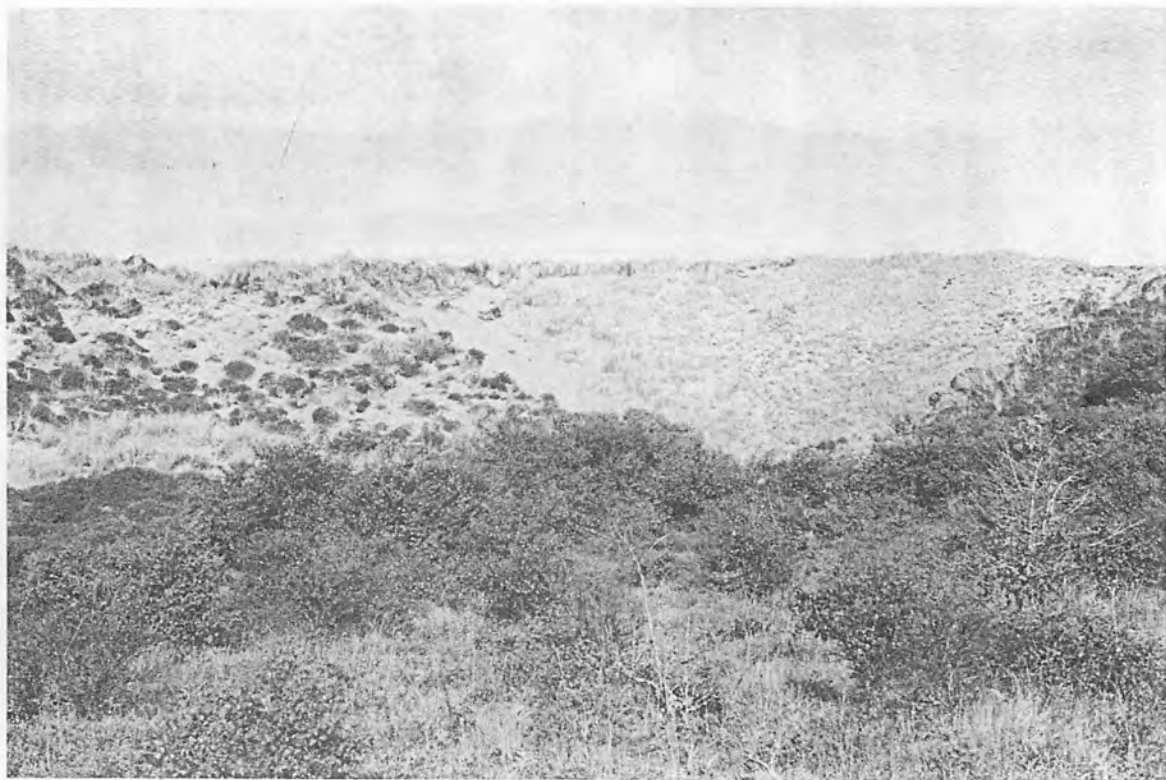
6.7.3. Coul Links - scrub invading damp slack behind high parabolic dune.

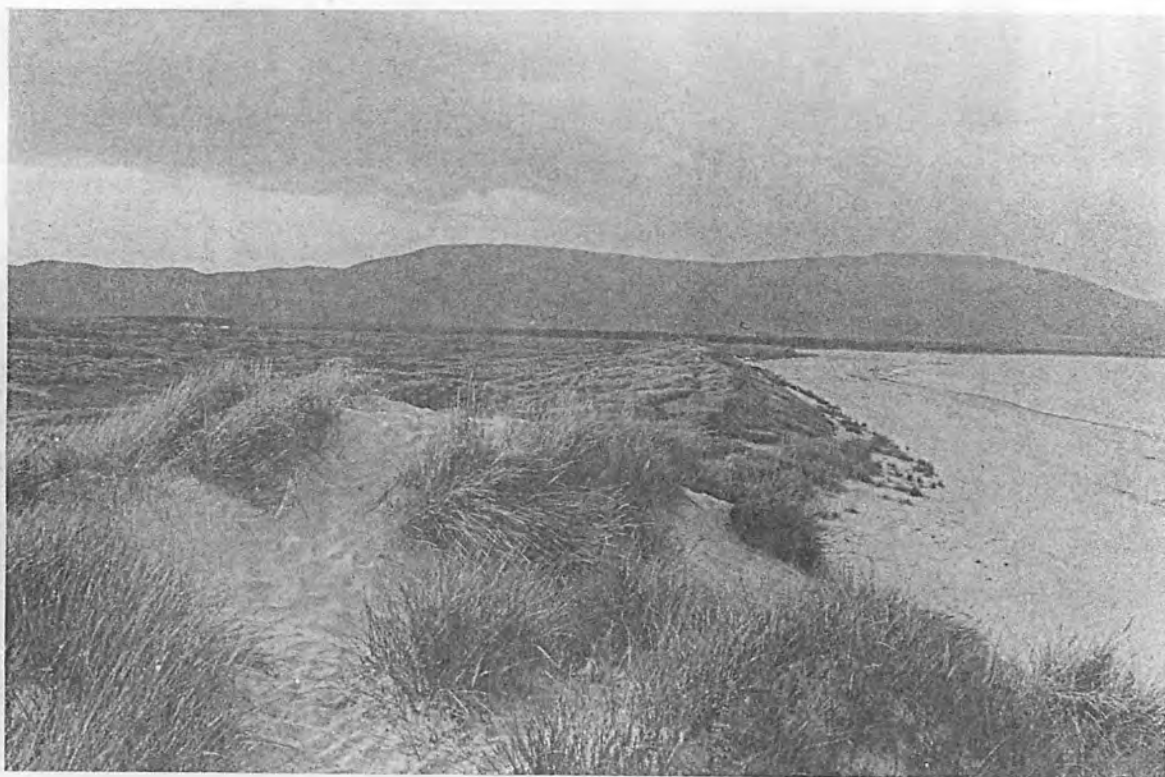
6.7.4. Coul Links - south end near Embo village. A path has been trampled along the dune crest.

The main foredune ridge is also being modified. The seaward part of the ridge is still unfixed, but blow outs are few except in the section immediately north of Embo where rapid deflation is occurring. There is more trampling damage in this section of the dunes than in any other part of Coul Links, and the instability may have been triggered off by this damage.

The existing intensity of recreational use at the north end of the beach complex is not incompatible with conservation, and can be permitted to continue without implementing specific management measures. Some trampling damage has resulted from recreational use of the dunes immediately north of Embo, however, and there are indications that stability is deteriorating. Most of the damage is concentrated in a dune-crest pathway, and cannot be effectively remedied without closure of the pathway by fencing, and diversion of the pedestrian traffic either along the beach or else along the more stable lower part of the dune backslope. Such action is probably not immediately necessary, but may become imperative in two or three years if the present intensity of use is maintained. If remedial action is not then taken, much of the dune ridge for about 300m north of Embo could be mobilised.

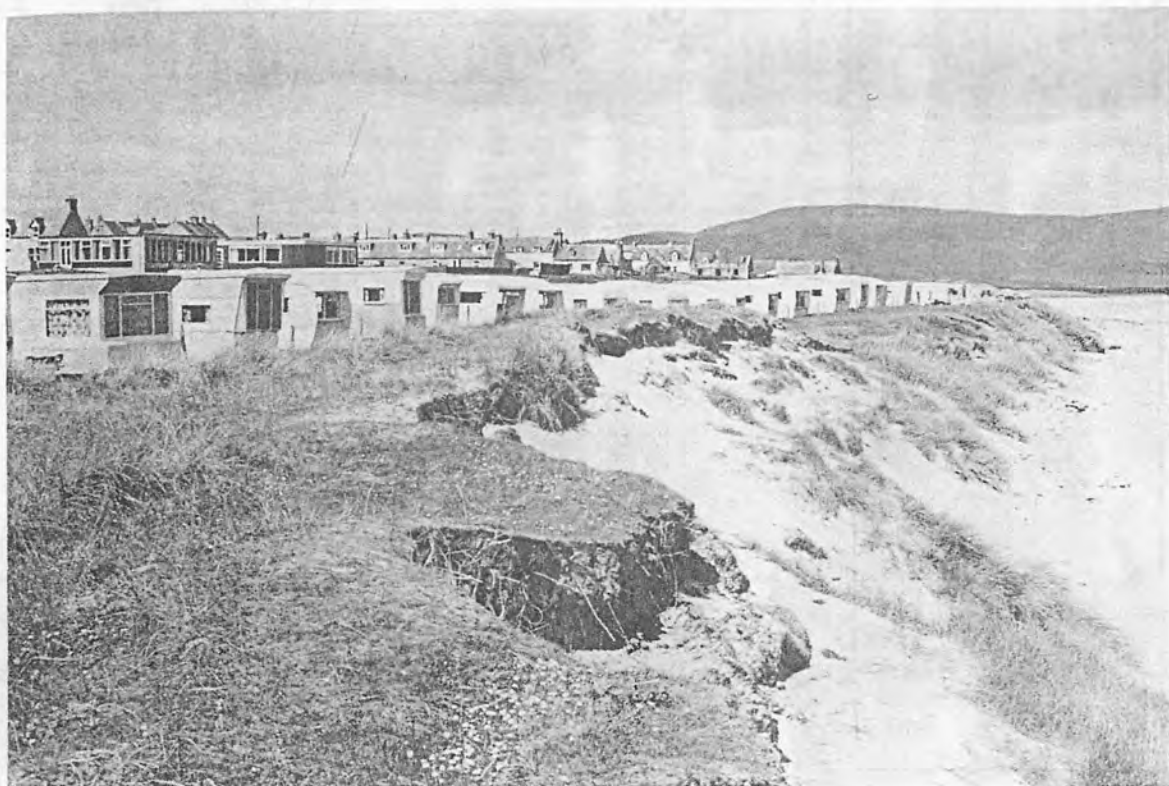
6.8.3. Embo - caravan site and beach.

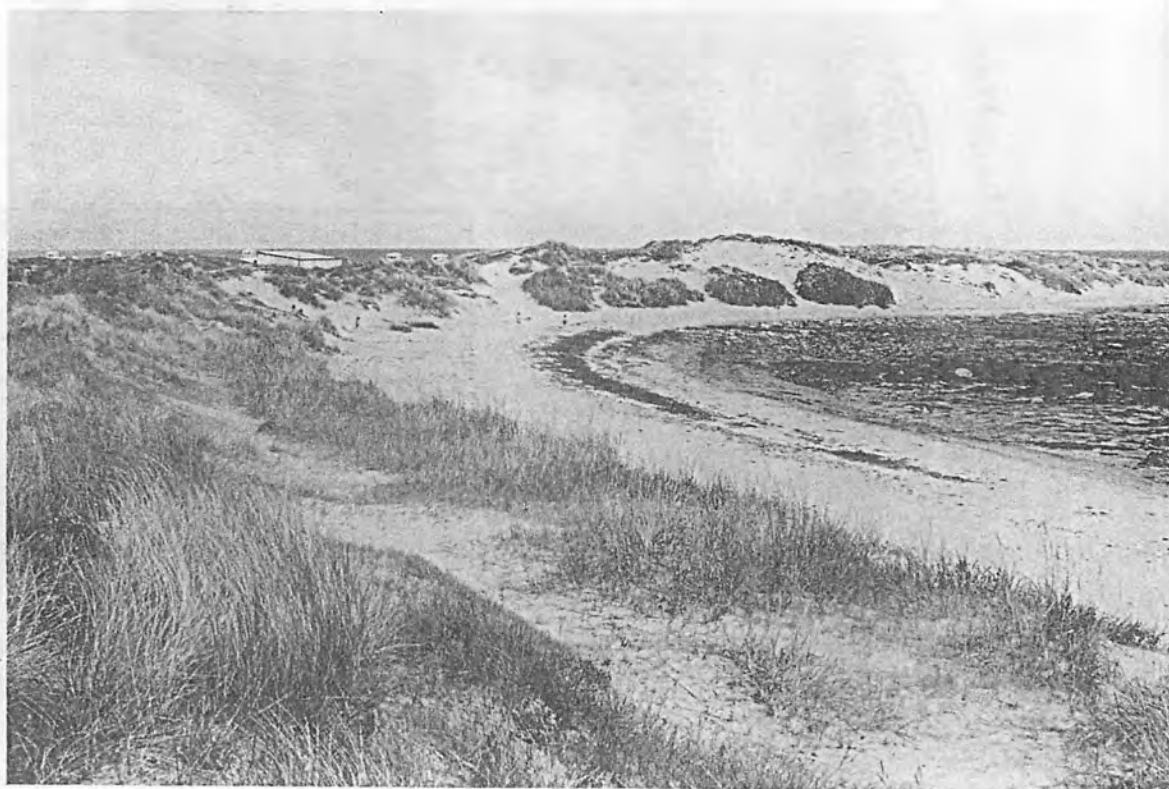
6.8.4. Embo beach and dunes - south and central sections, note narrowness of sandy beach fringe.

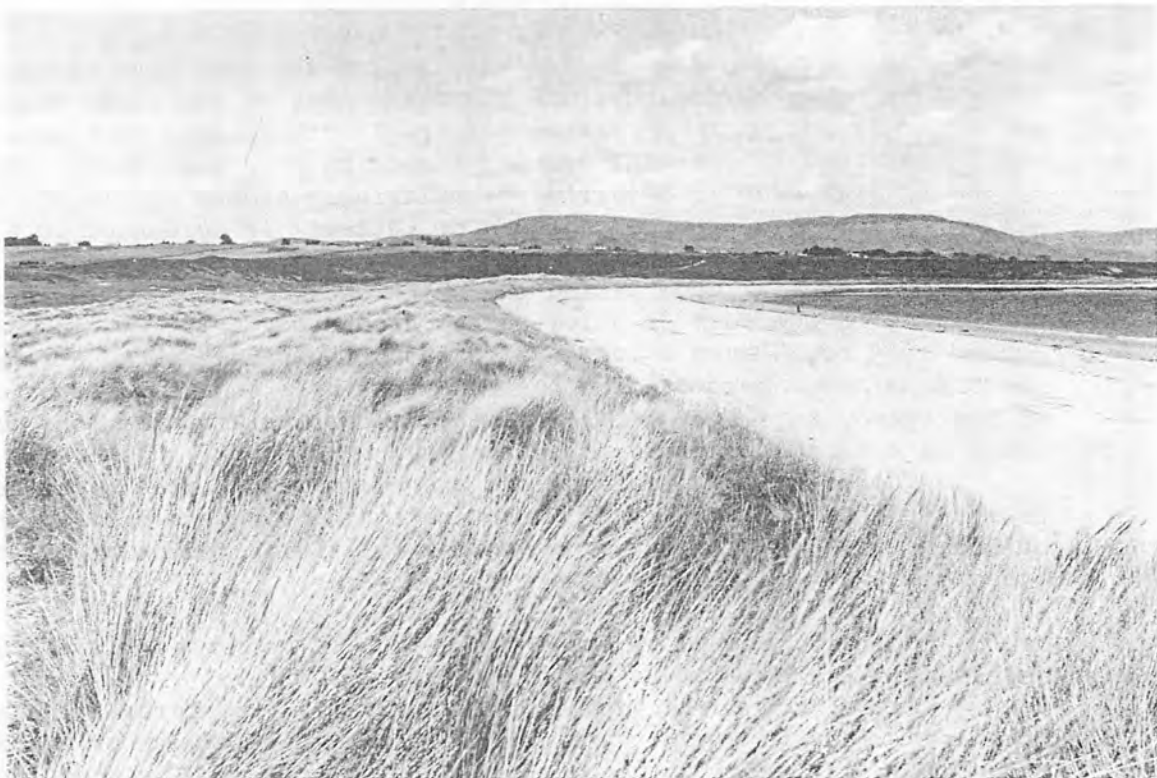
6.9.1. Dornoch North - note the wide beach, and subdued foredune ridge.

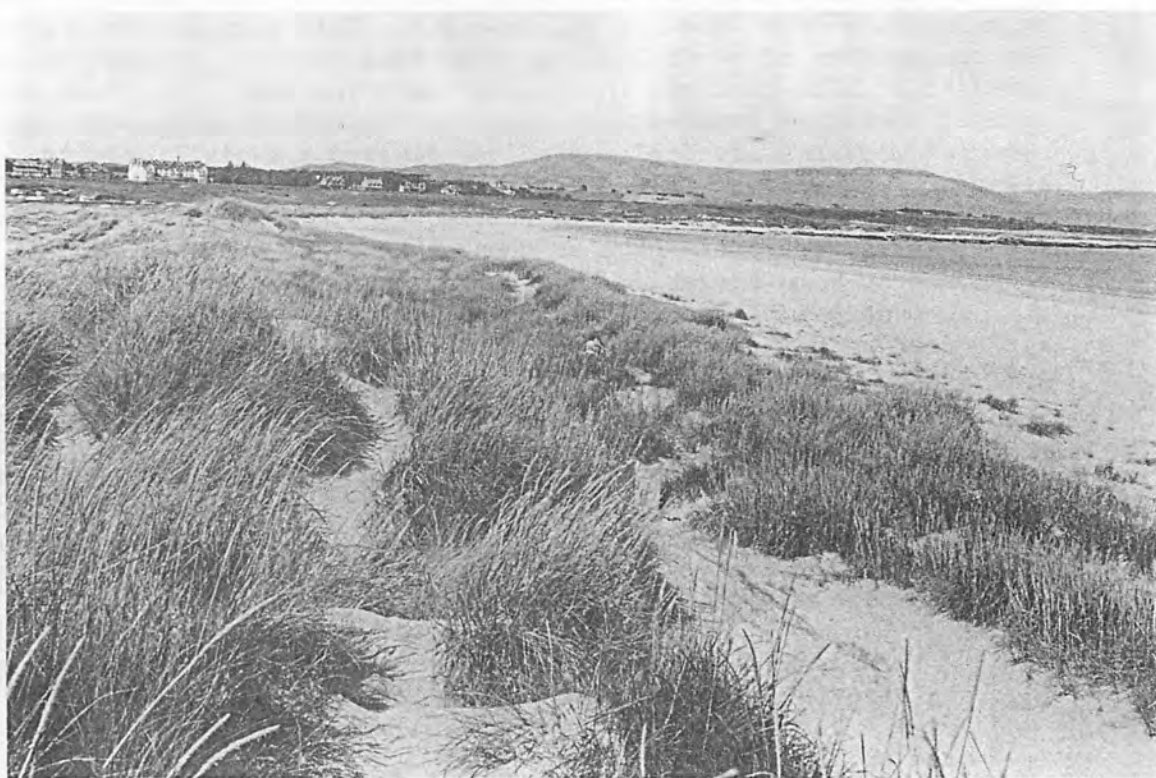
6.10.1. Dornoch South - note vigorous accretion along the coastal edge.

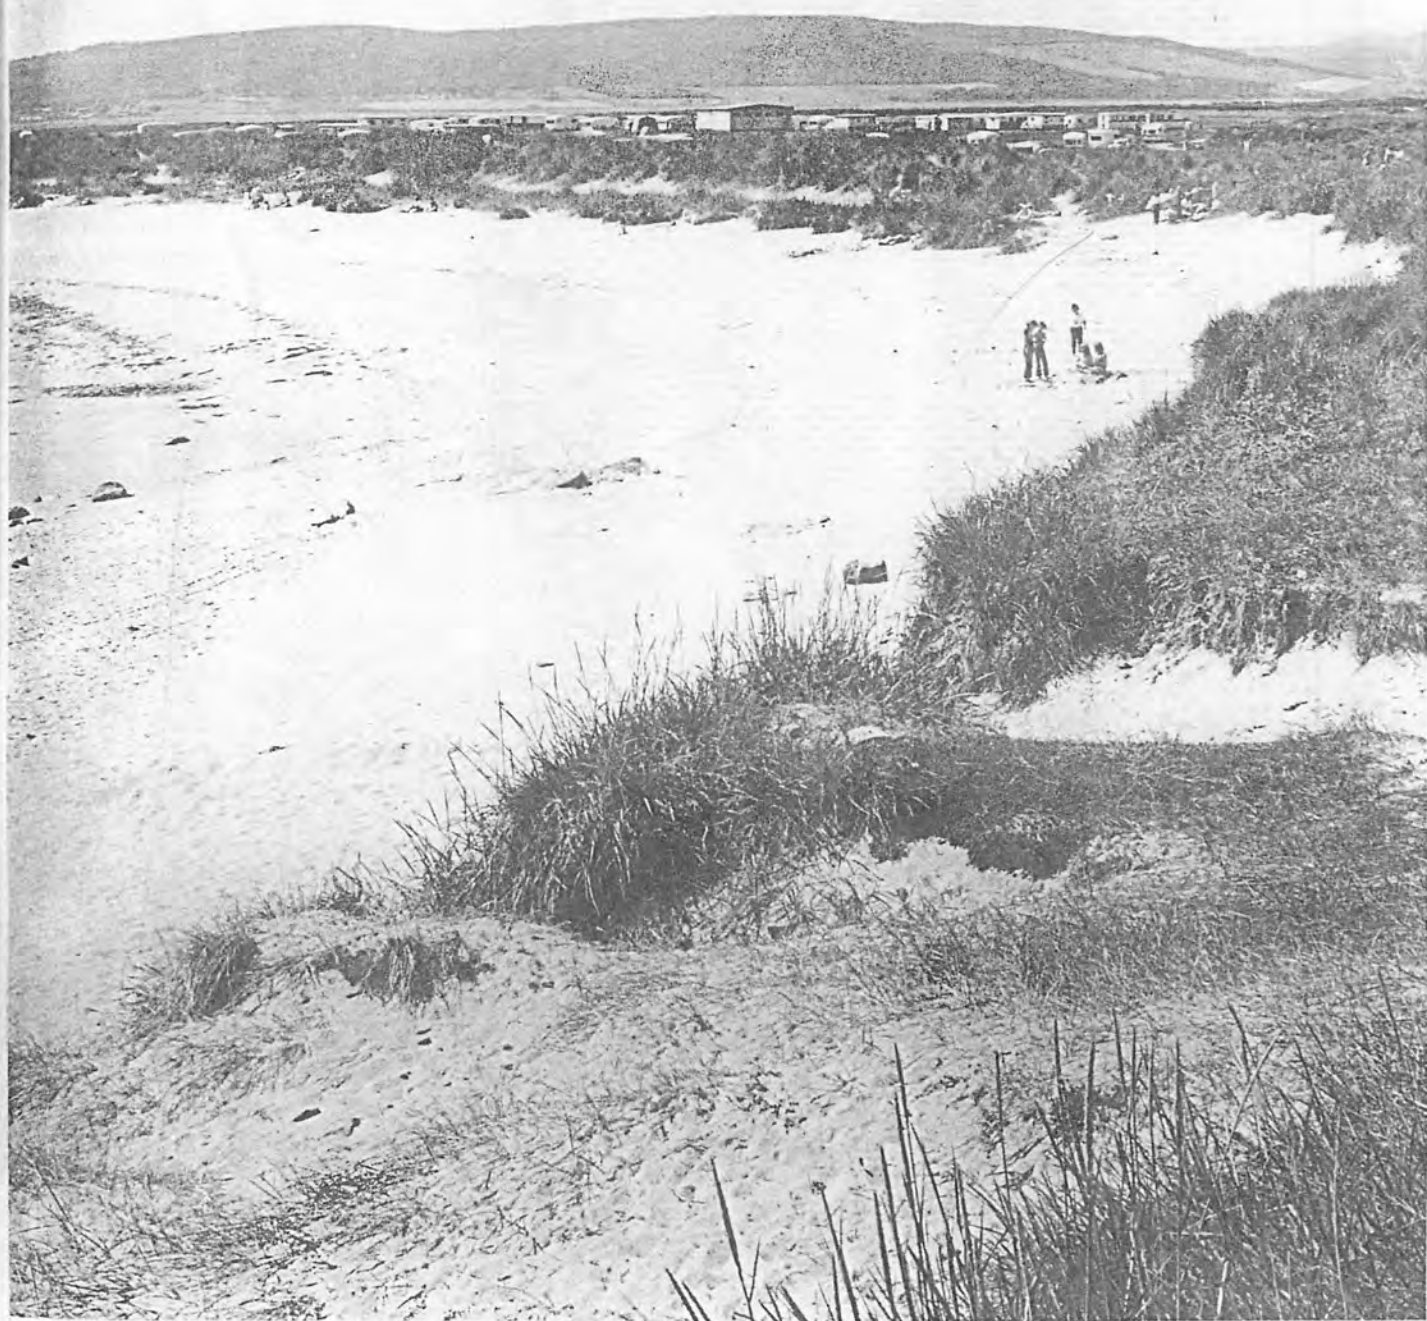
6.10.2. Dornoch south - note trampling damage in foreground.

The north part of the beach and the adjacent dunes are also used intensively by day visitors, and during fine days in summer up to fifty cars may be seen in and around the car park at the end of the beach road. Trampling damage is widespread along much of the adjacent coastal edge, part of which is fortunately rock-cored and relatively resilient. Blow outs are nevertheless developing around some of the worst trampled points, and the entire section of coastal edge between the car park and the burn bears the imprint of heavy pressure. This pressure has thus far resulted in remarkably little wind erosion; had it been located on less stable physical conditions, the environmental repercussions might have been grave.

In the north dunes, near the caravan site and car park, trampling damage could be reduced by the simple expedient of channelling pedestrian traffic through a small number of controllable points. To achieve this objective, a strong fence should be constructed along the top of the coastal edge, with not less than six gaps left for through access to the beach. The gaps at the car park end should be protected by sleeper staircases; those nearer the stream would be best safeguarded by duckboard walks, which could if necessary be extended backwards across the dune ridge if trampling damage becomes severe. These measures would help to reduce many of the signs of wear and tear around the beach margin, and at the same time would permit the safe continuation of the present intensities of use.

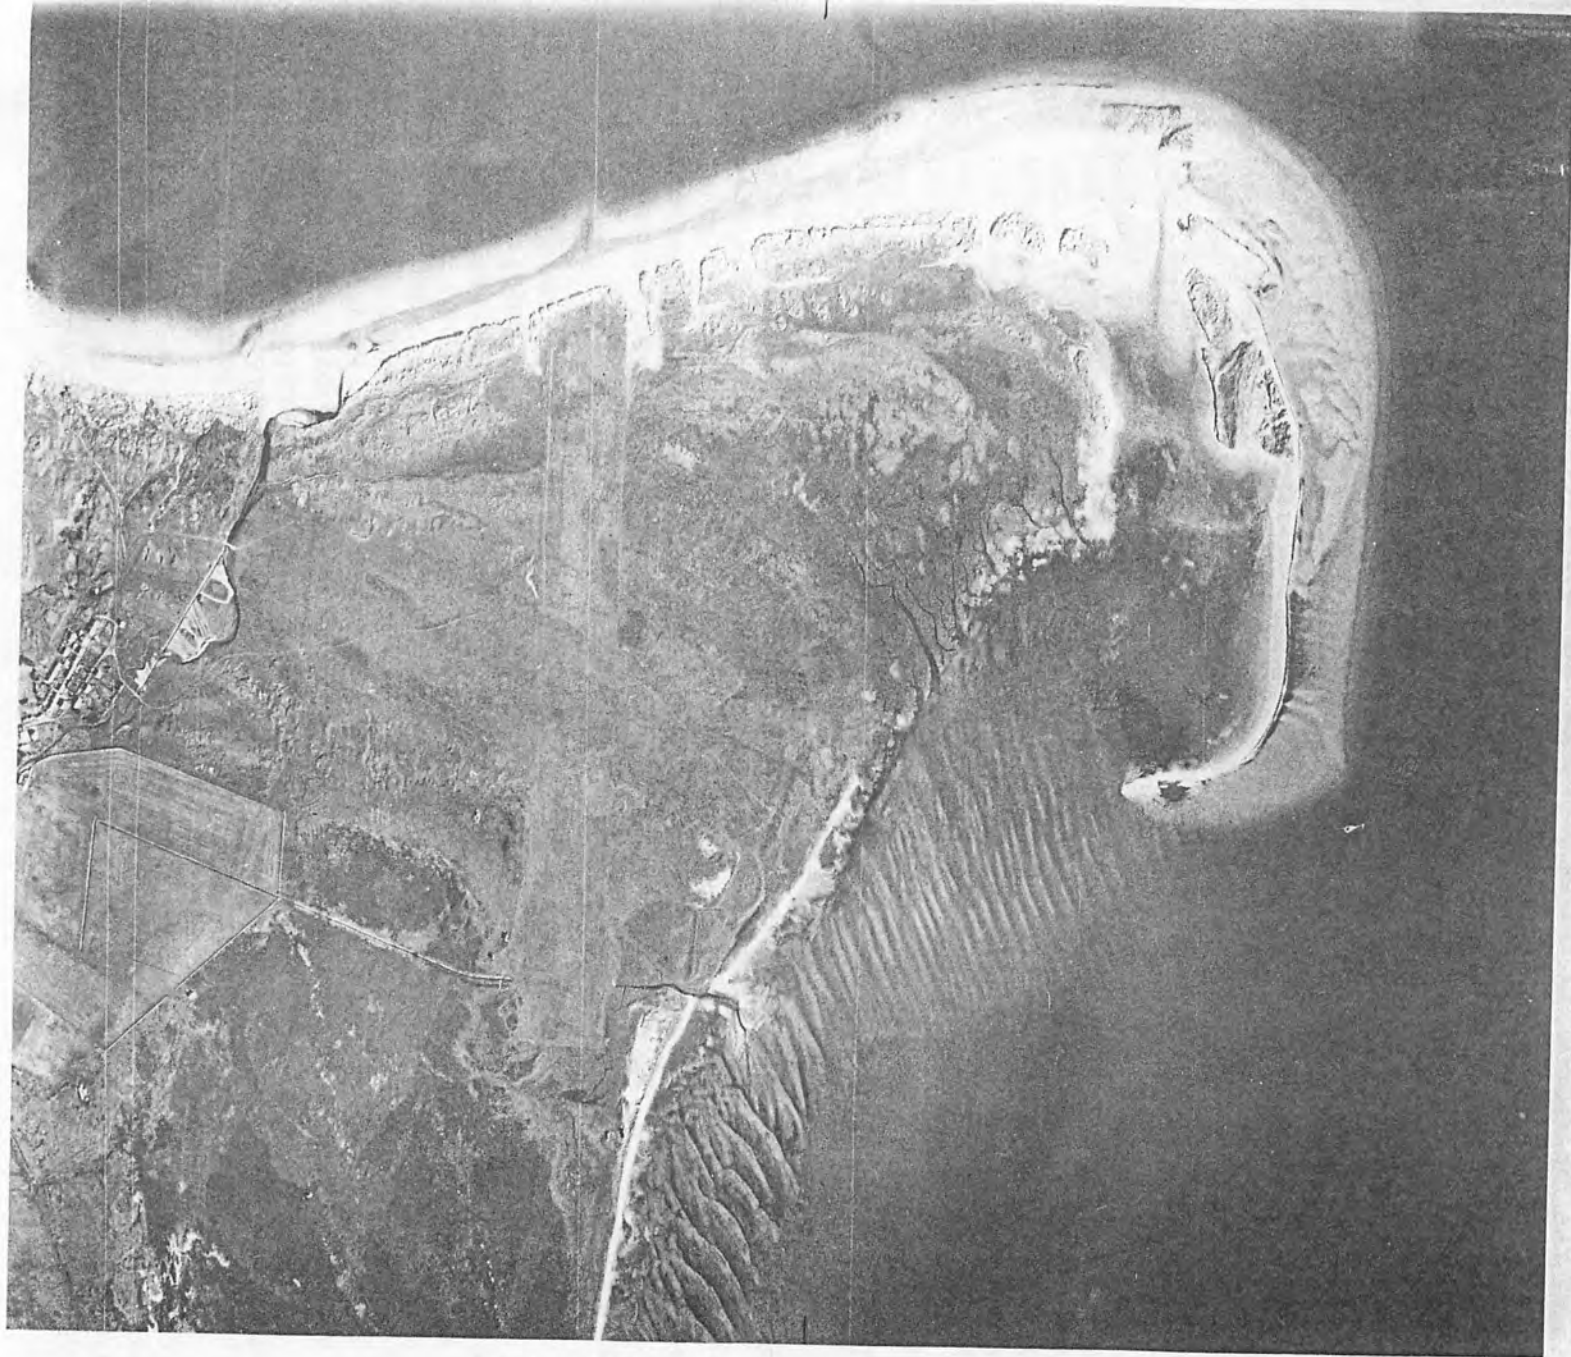
6.10.3. Dornoch Point (1959) - the caravan site occupies the area near the top of the picture, mainly on the north side of the stream.
