Archaeology Report: Site for New Housing

The Square: Dornoch, Sutherland

Site Code:	HAS/DBP07
Grid Reference:	NH 798 896
Client:	JA Property Development Ltd
Report Date / revision:	20 April 2008
Authors:	Emma Malone and John Wood

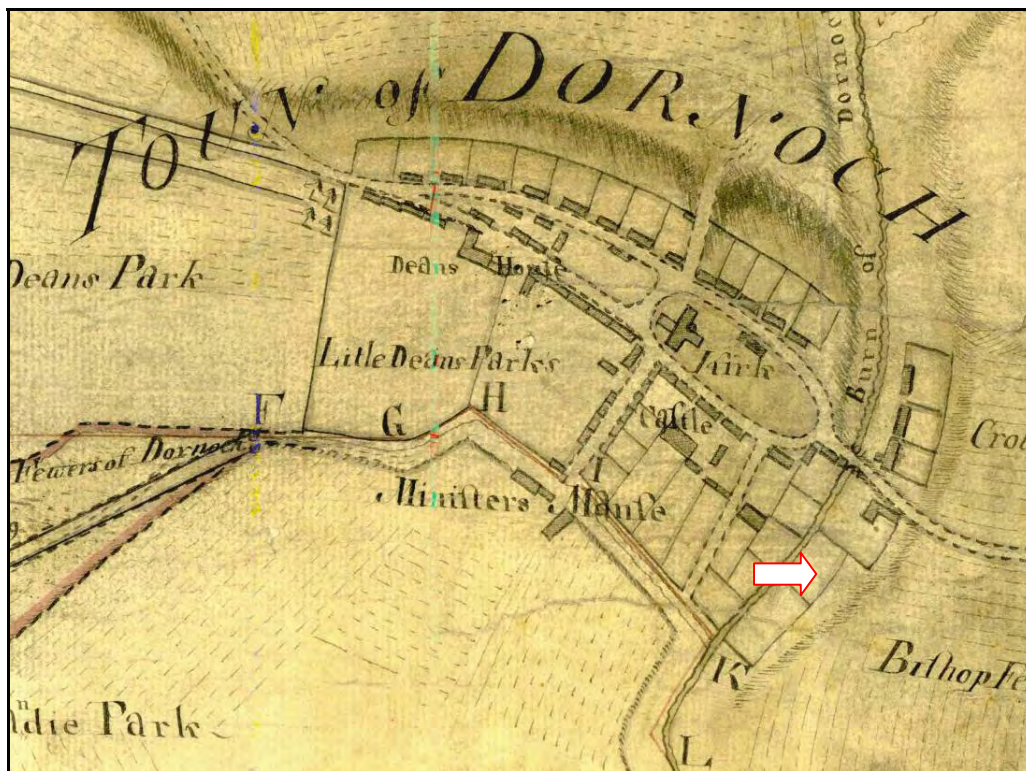
Figure 3 Dornoch 1783

A map of Dornoch in 1783 shows the eastern boundary of the town running roughly along the line of the Dornoch Burn. The present site was therefore in fields at that time. It is not clear whether the town had previously extended further but this seems unlikely.

Courtesy of National Library of Scotland. Arrow shows approximate location of site.

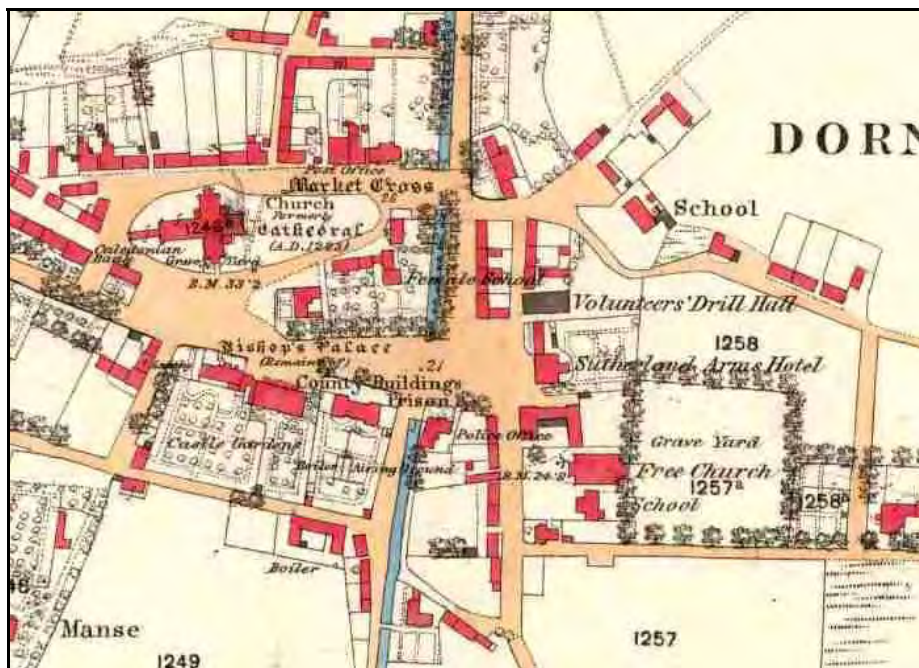
Figure 6 Dornoch 1878

Ordnance Survey 1:2500 map – not to original scale. Courtesy of National Library of Scotland.

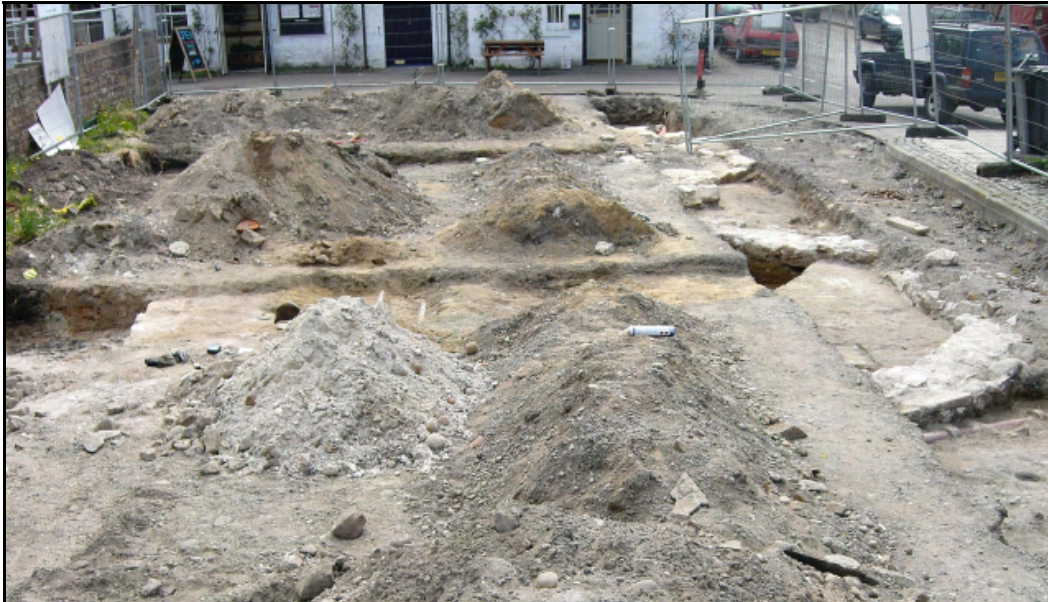
Plate 4: Trial trenches showing walls of the Sutherland Arms

Structures and deposits certainly associated with the Sutherland Arms Hotel were uncovered in Trench 1. The remains were identified using old hotel photographs from the Dornoch Historylinks museum that show the front of the hotel coinciding with the approximate position of Trench 1. The Ordnance Survey 2nd edition map (1909) was scaled up to create the outline of the hotel dimensions, which could then be overlaid with the 1:20 site plans. The 1909 photo compared with a photo of about 1930 show clearly that the timber veranda visible in 1909 had been demolished by the 1930s for the construction of a conservatory and the castellated doorway and bay window additions to the old building. The castellated addition was evidently designed to match the design of the new building.

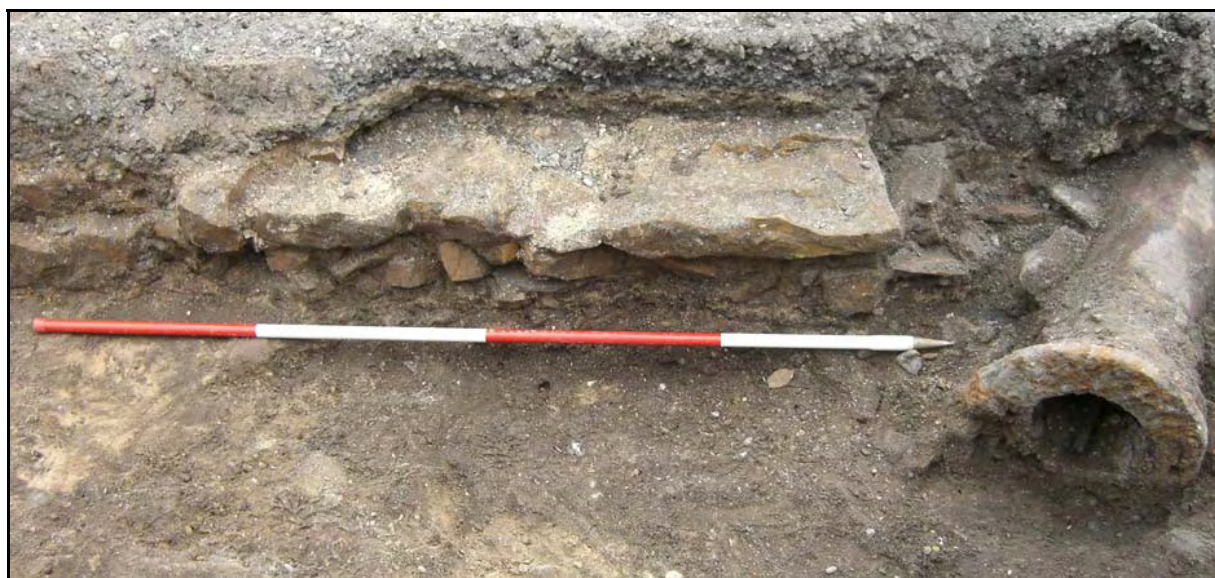
Plate 5: Structure [131]

Scale in 50cm divisions

Evidence of the main (newer) hotel building was uncovered north of the conservatory footings (see Plate 5 below). A length of sandstone slab overlying sandstone fragments (Structure [131]) along the trench extended approximately 10-20cm from the east edge of T1. It is underlain by Cut [142], probably associated with the hotel's construction. The location and orientation of the footings line up with the conservatory and bay window to tie in with the position for the main hotel.

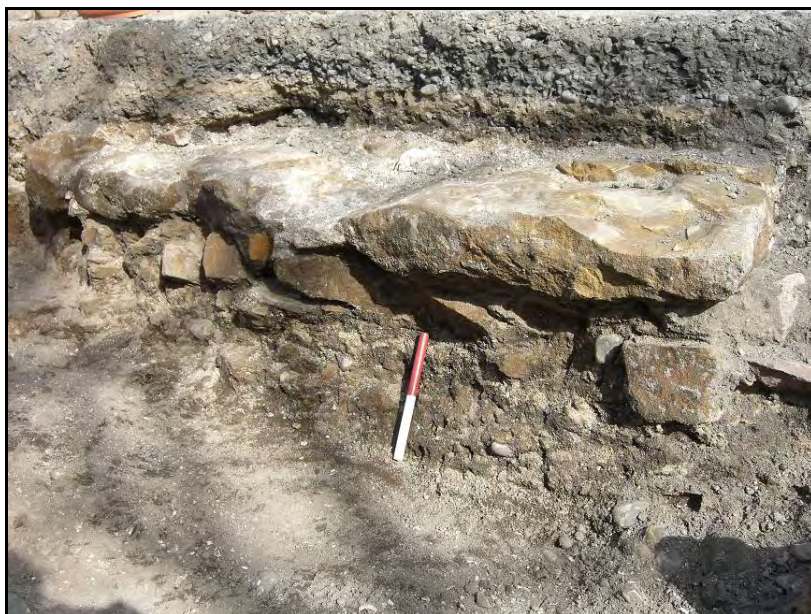
Plate 6 Structure 155

In Trench 1, a nicely hewn sandstone drain (Structure [155] on Plan 10) was uncovered at the bottom of Cut [121] (= Cuts [116 / 304]). The identification of the cut itself was at first confused by the nature of its mixed fill [150], the overlying conservatory footing [119] and Cut [117]. But further excavation revealed that Cut [116] and Cut [121] were the same. Structure [155] was constructed of large yellow sandstone slabs lined on the sides by cobbles which covers a sandstone-slab drain passage. The drain runs across the trench along a southwest-northeast axis (see Plans 6, 10). Analysis of the stratigraphy (seen in the Cut [121] profile in Photo 51) showed that Cut [121] was made through Deposits [122], [151], and [153], all of which are potential surfaces of interest. No finds were recovered in association with the drain.

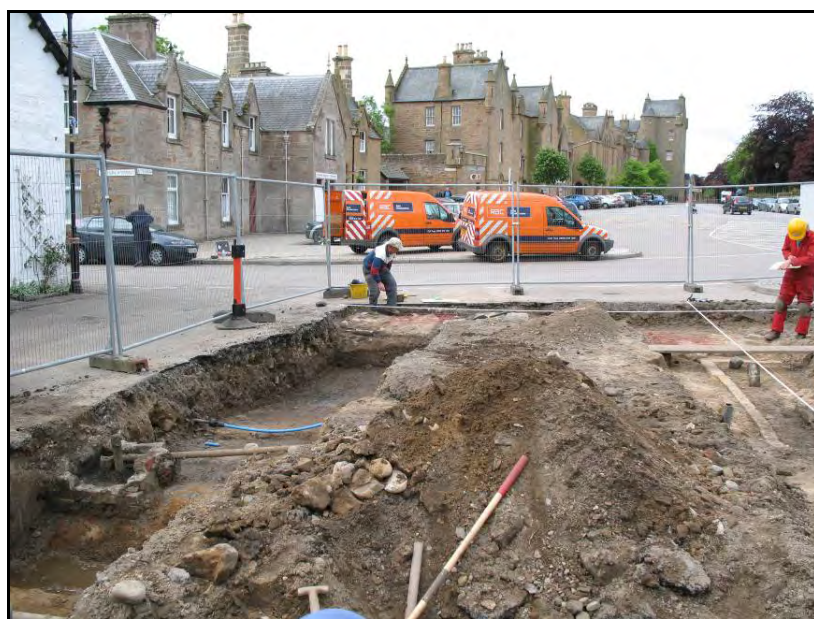
Plate 7 Diesel Tank in Trench 5

Trench 5 The uppermost deposit [500] was removed to reveal two petrol tanks: one was expected; the other was not. Some dark, possibly burnt indistinct areas were identified in the centre of the trench. These were cleaned but remained indistinct and appear to have been within some re-deposited material associated with these petrol tanks: the area of disturbance surrounding the old tanks was not clearly defined, despite attempts to identify an edge to the re-deposited soil the cut could not be found, which is most likely because considerable contamination had occurred in this trench with spillage or leakage of petrol from the tanks, in addition, oral history has hinted that owing to the high water-table in Dornoch the petrol tanks floated on the tide, until they were finally secured. This would have had an abrasive effect on the cut edge.

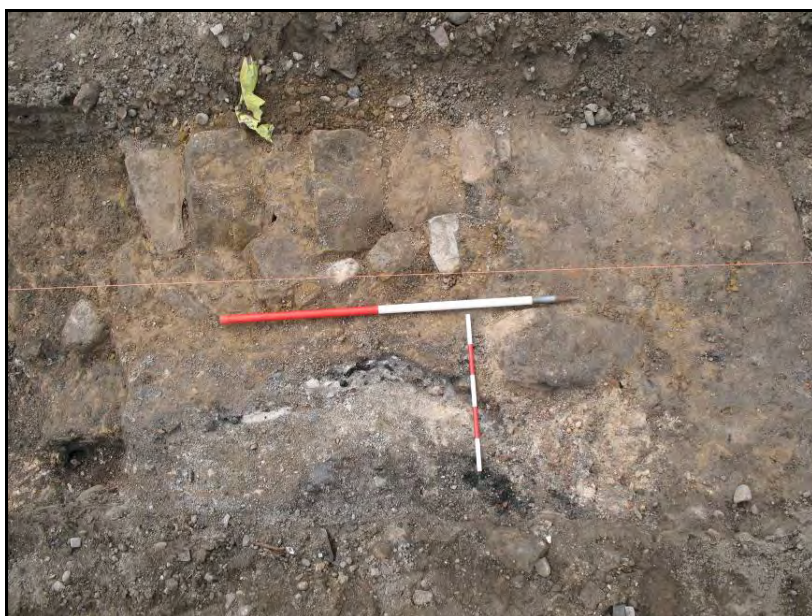
Plate 8 Footings of gable wall appearing in Trench 6

Trench 6 Beneath the top surface material [600], sections of walling from the first phase of the Sutherland Arms Hotel were identified. A narrow gap in the trench side revealed a horizontal void part-filled with a sandy context (Plate 7). It is possible that the iron beam is part of a system of supports for a cellar, though it may be associated with the old diesel tank set within a brick-walled pit just north of the iron beam. This is just west of a stone-covered drain, which presumably pre-dates the tank, but surprisingly remained in situ next to the retaining brick wall. A thick stone wall pre-dating the hotel exists at the east end of Trench 6, which turns and returns to the north. Elements of this wall were probably recycled into the building of the hotel

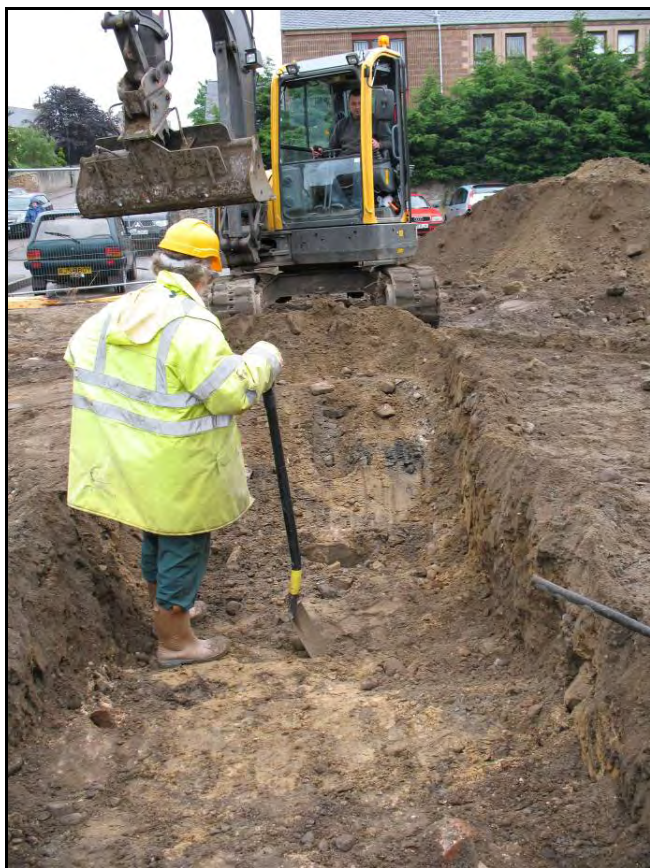
Plate 10 Trench 11 under initial excavation

Trenches 10 -12 These Trenches were almost completely sterile having been severely damaged by the filling station.
